Fredonia's Water Supply: Understanding the Source & Treatment

Presented: April 10, 2024

Chautauqua County Health Department

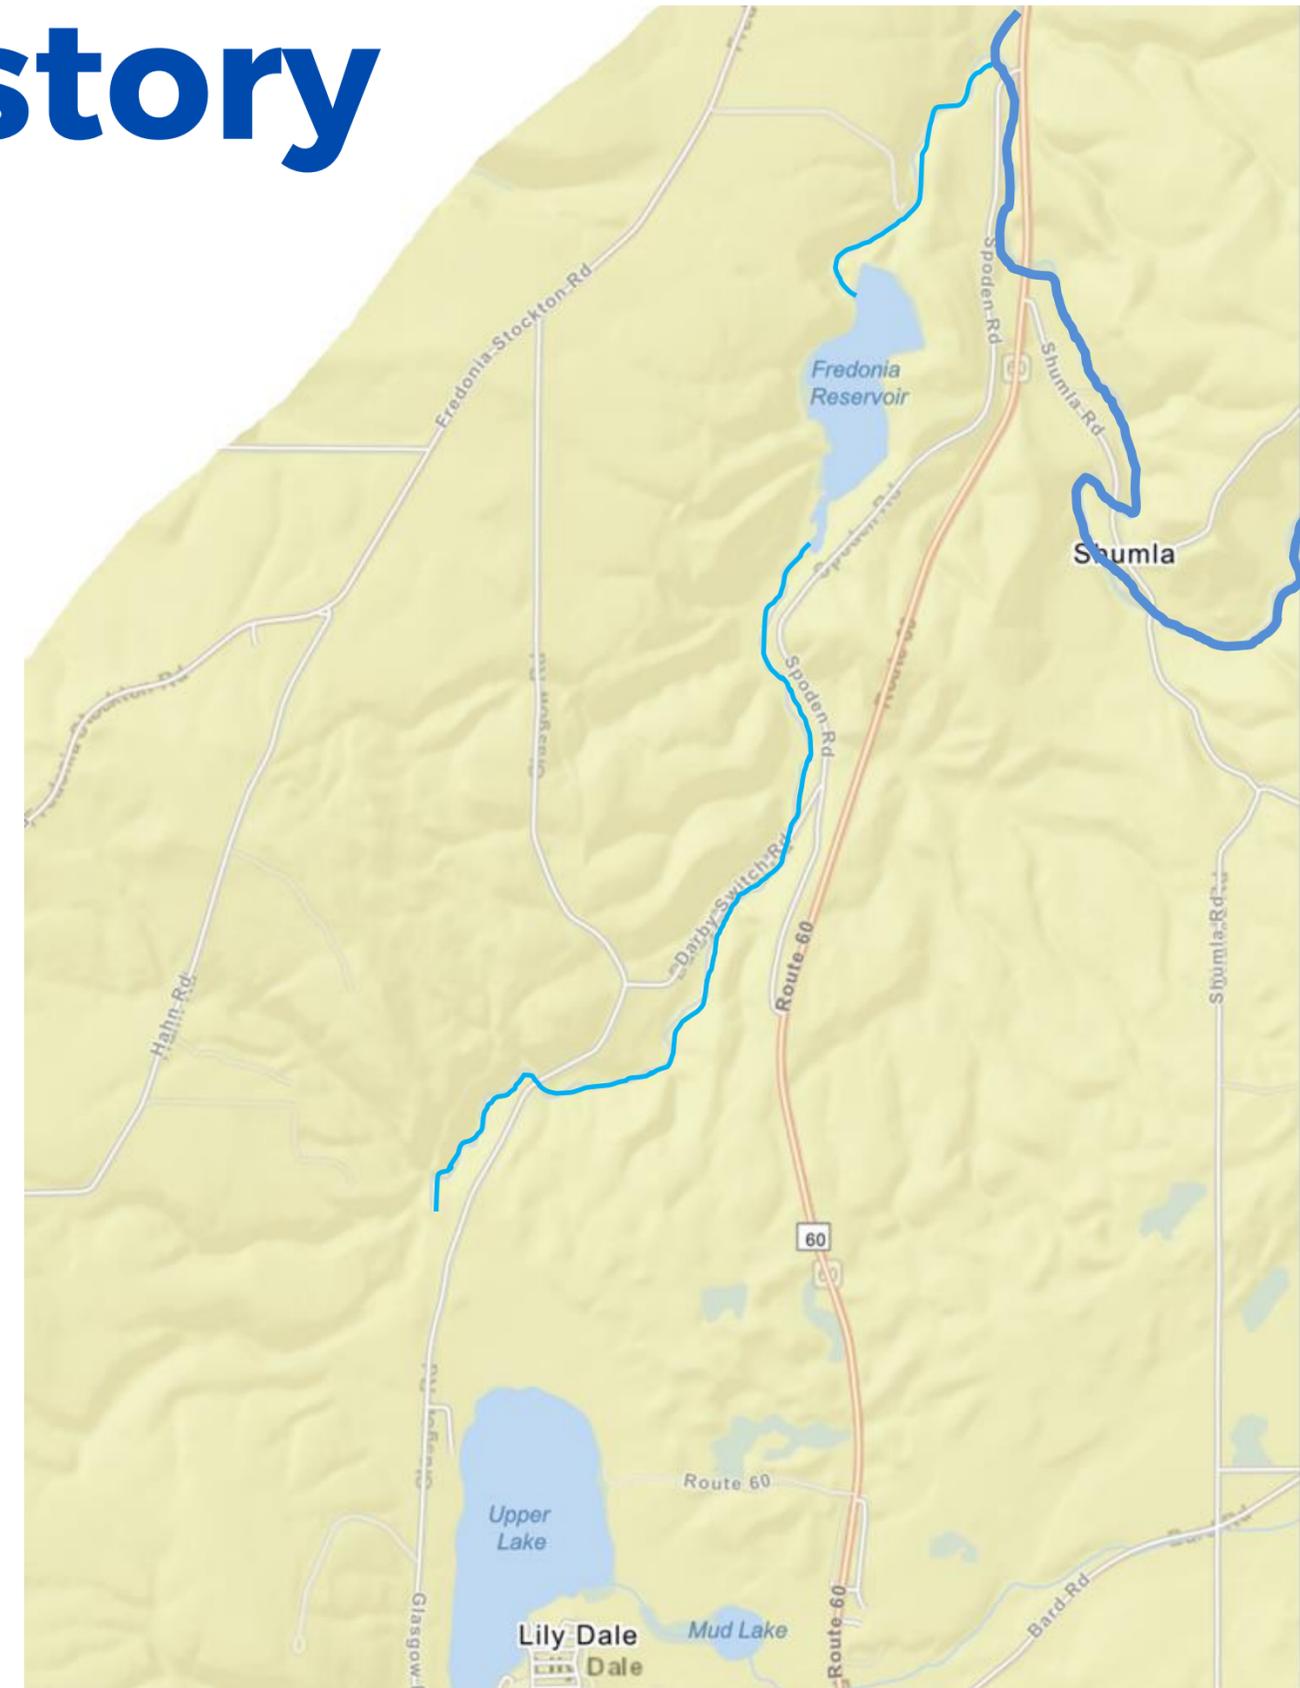
Fredonia Reservoir History

Not a naturally occurring water body.

1884 - Small reservoir (10 Million Gallons) created by damming an upper branch of Canadaway Creek.

1938 - Dam and spillway built to increase reservoir volume (332 MG) to supply growing Village.

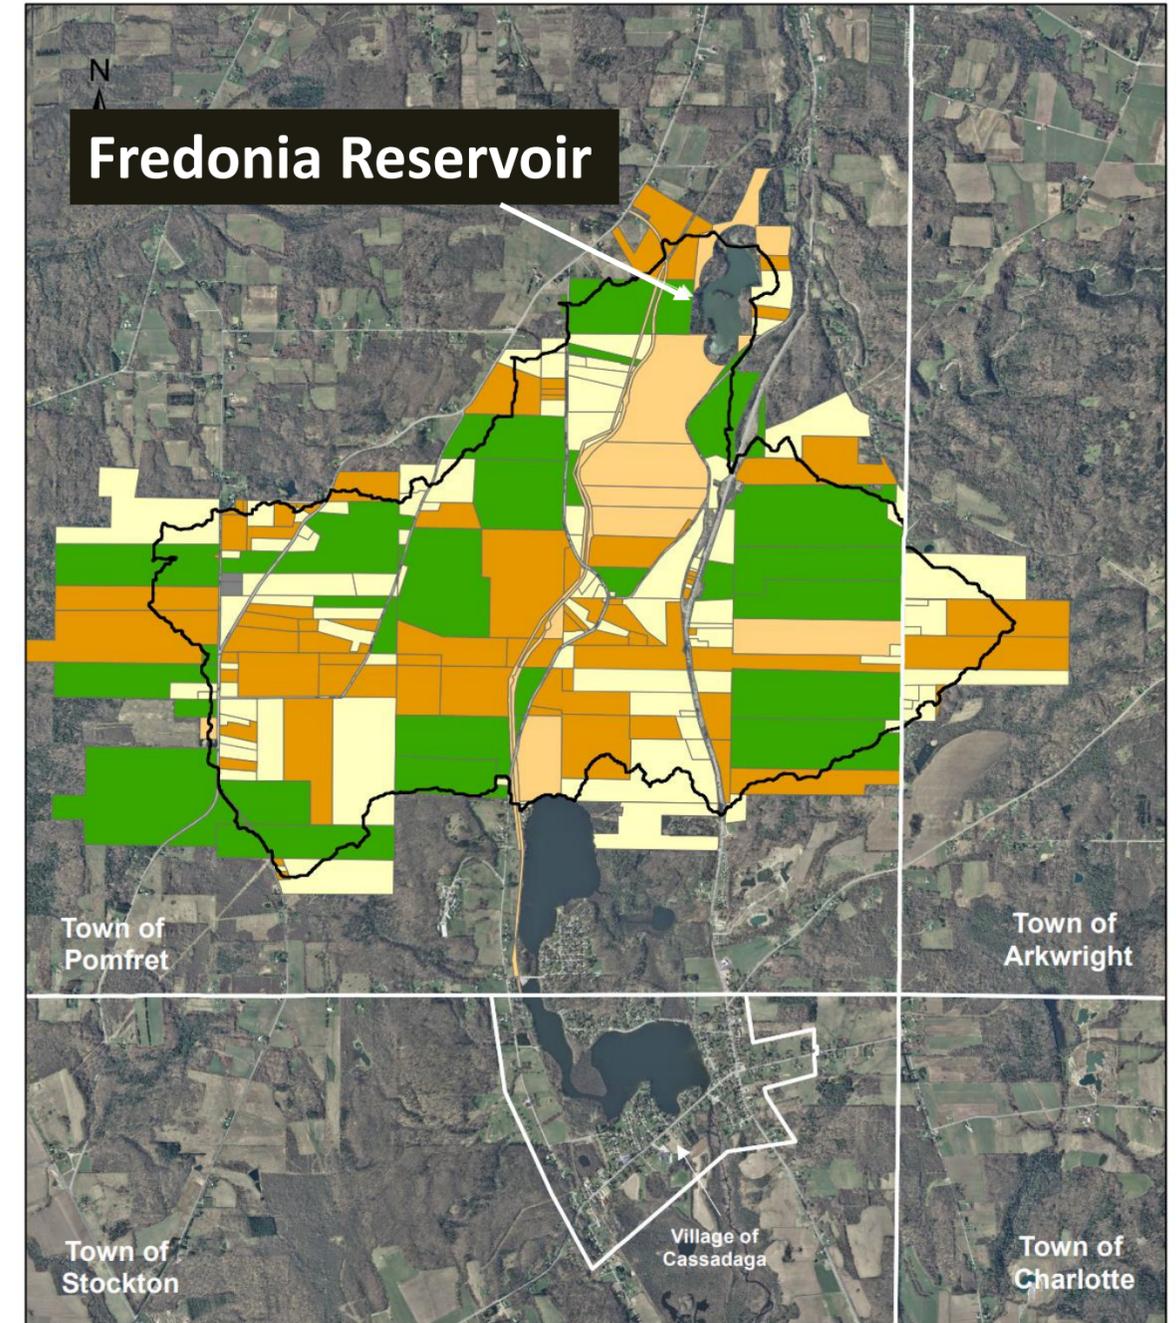
- Agriculture
- Village Owned
- Watershed
- Vacant
- Residential (includes MHPs & camps)

Fredonia Reservoir Land Use Map.
Based off of New York State
Property Class Codes.

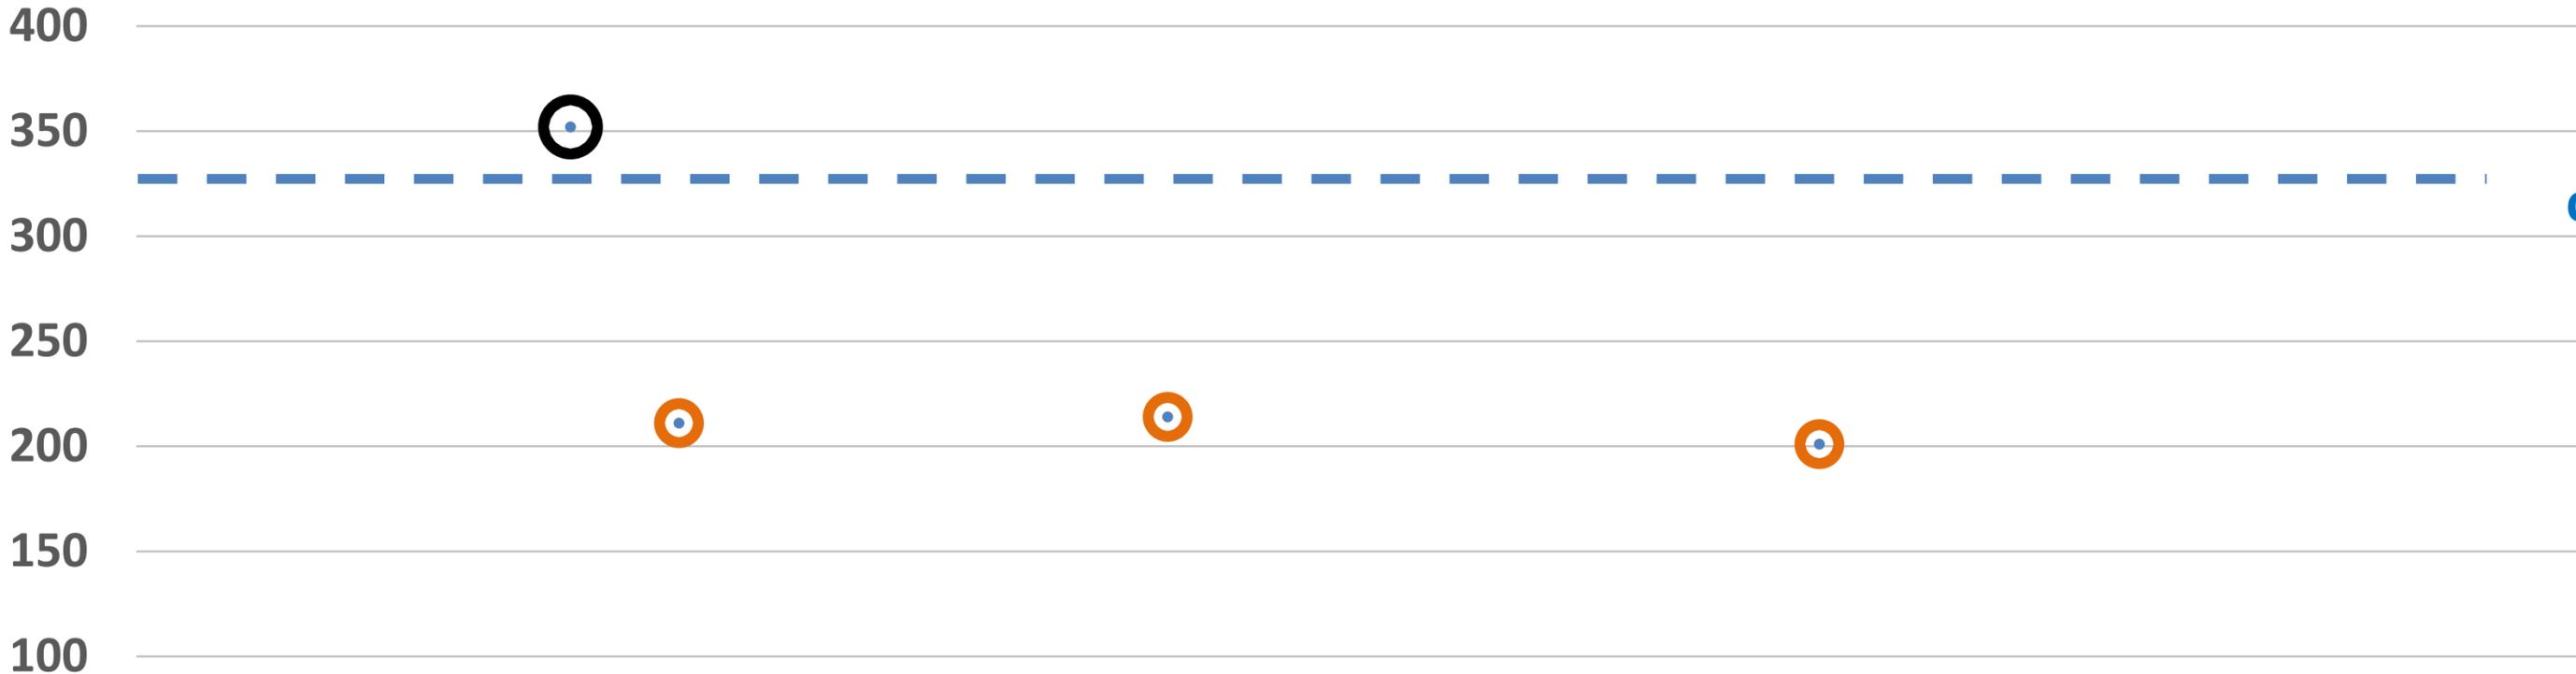
Fredonia Reservoir Capacity

1938
Original capacity = 332 MG

1988
Potential capacity = 352 MG
(spillway was raised to increase total volume)

1990
Usable water = 211 MG
(Pieczonka Engineering)

1999
Usable water = 214 MG
(Harza Engineering)

2011
Usable water = 201 MG
(O'Brien & Gere Engineering)

2024
Usable Water = ??? MG

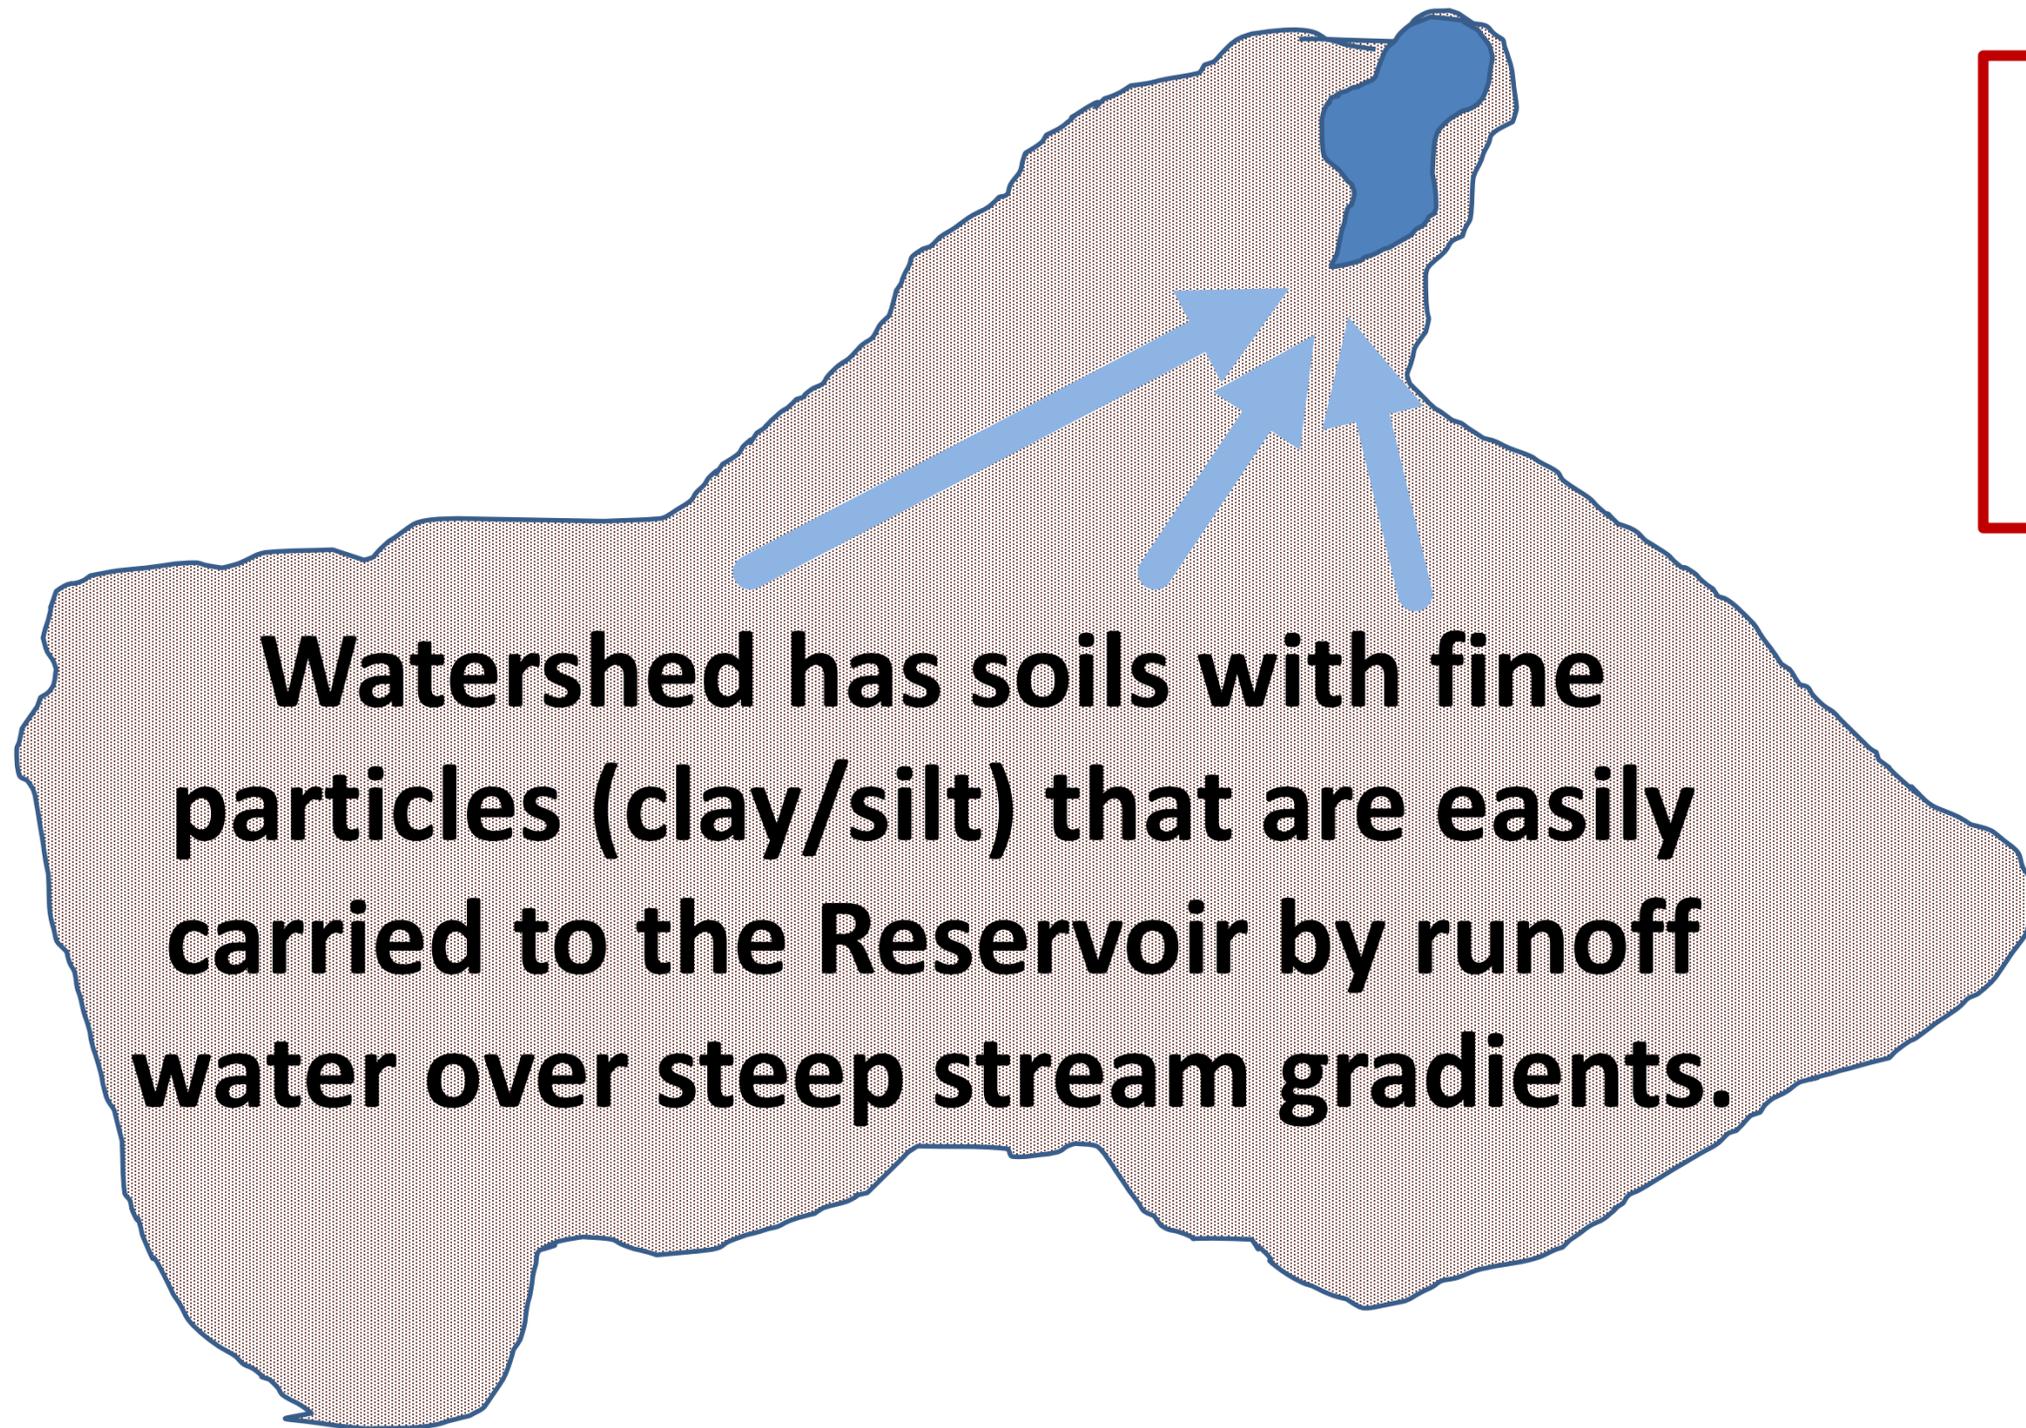
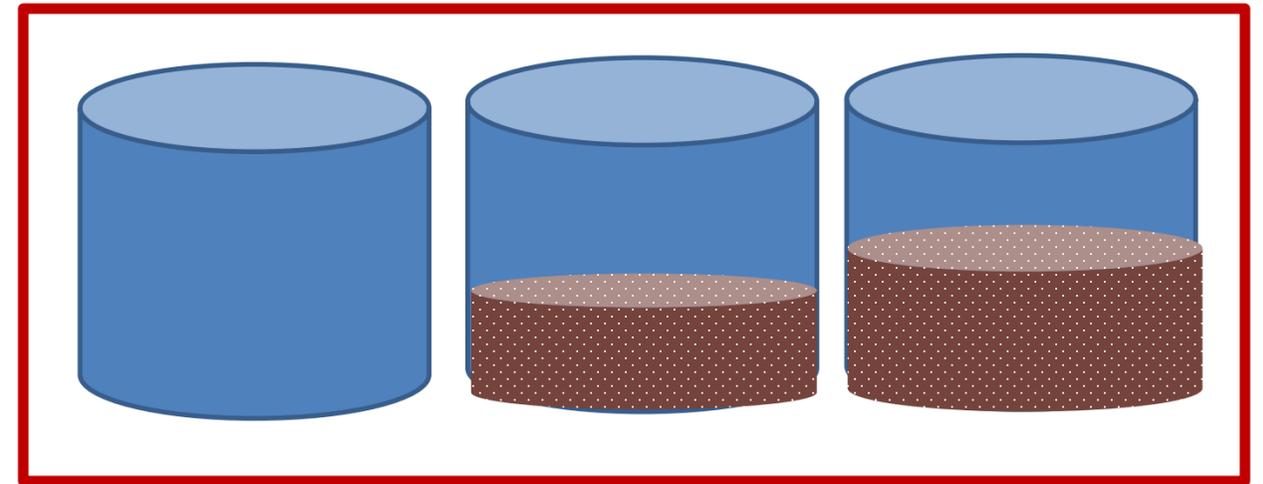
Sedimentation in the Reservoir

The reservoir water is calm so fine particles settle out of the water and “fill in” the reservoir.

2011 O'Brien and Gere estimated

43% of original usable reservoir volume was lost due to sedimentation.

Roughly 50,000 dump trucks (15 yd³) of soil had been washed into the reservoir.

- Dredging maintains the volume of usable water in the reservoir.
- Dredging reduces the amount of sediment that can cause turbidity problems at water treatment plant.
- Extreme weather events increase amount of sediment flowing into reservoir.

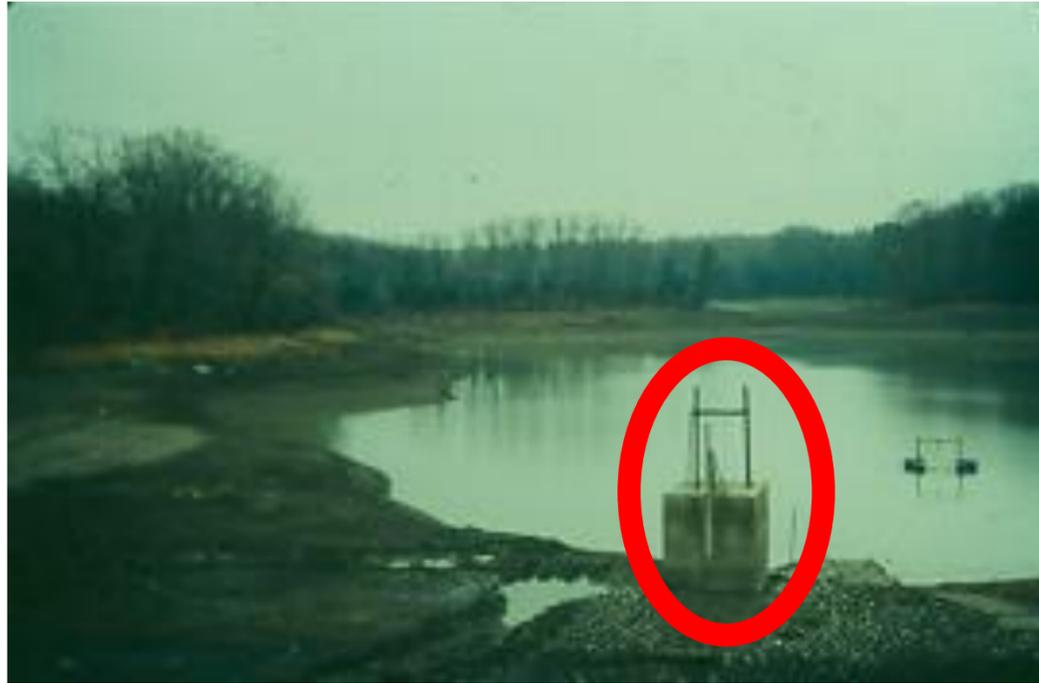
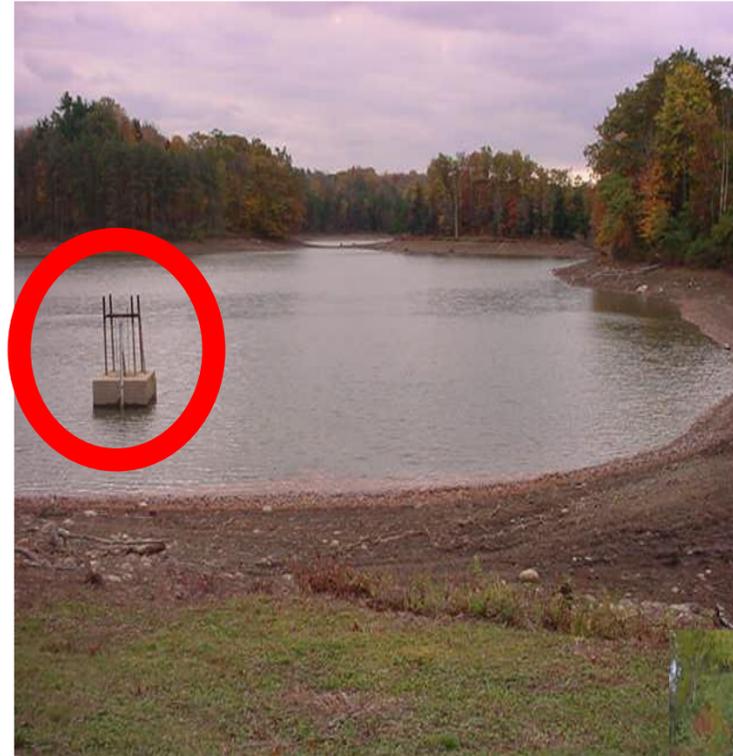
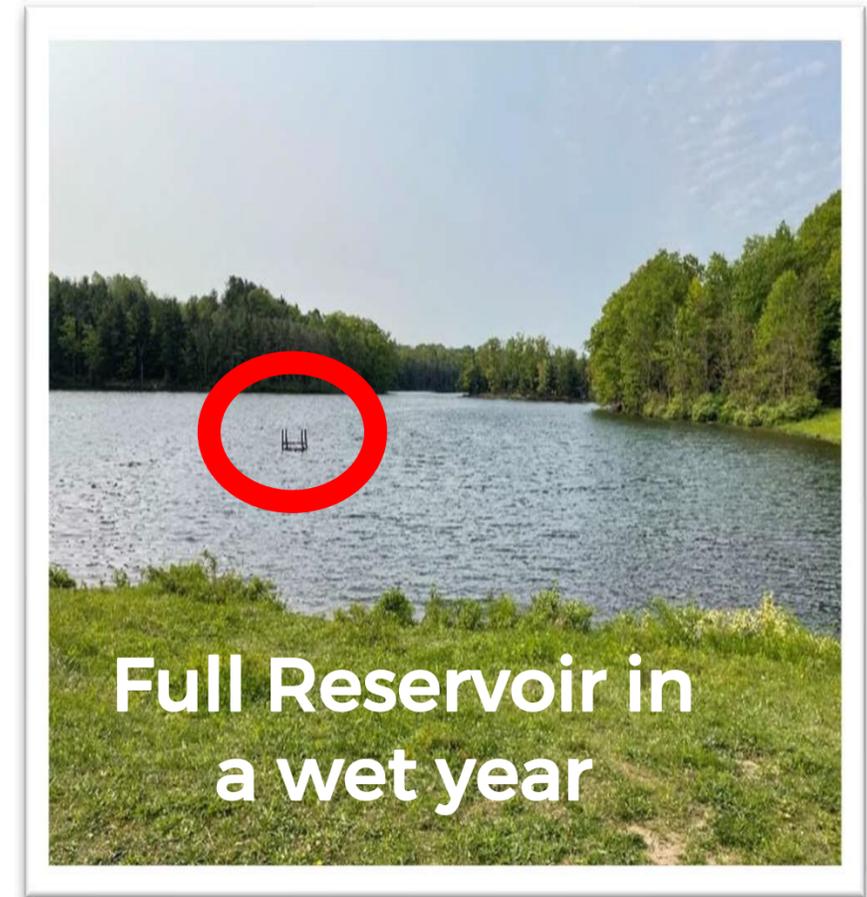
Reservoir Drought History

1991 - Reservoir depleted by 95%

1998 / 1999 - Reservoir depleted by 78%

2007 - Reservoir depleted by 60%

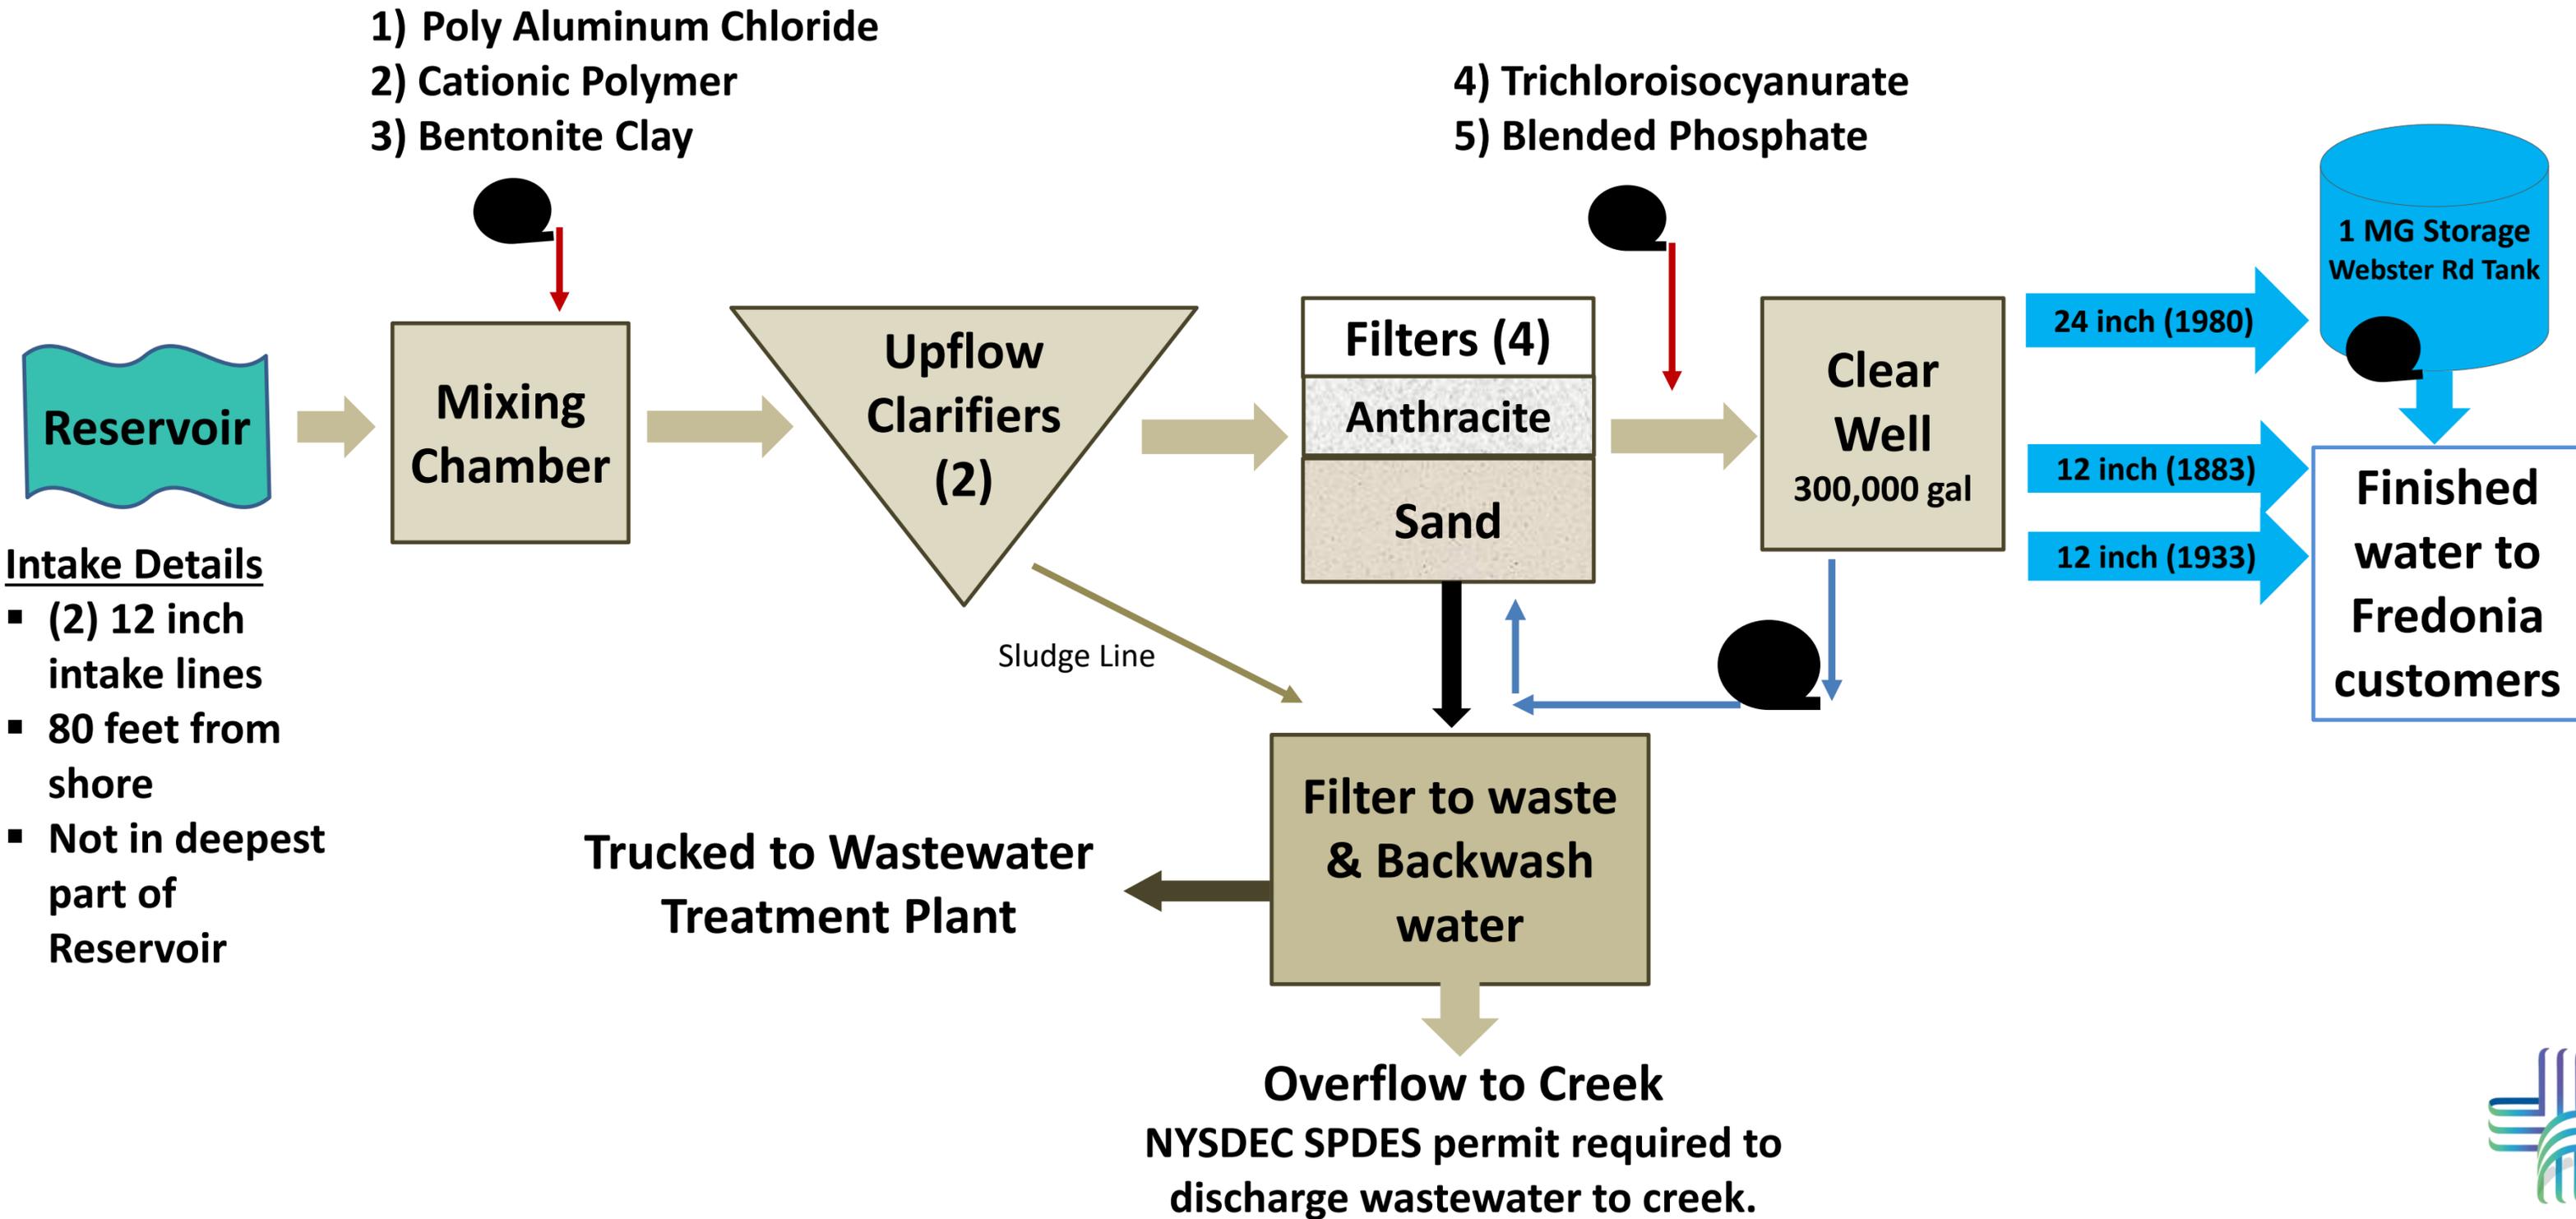
Fredonia Water Treatment Plant

- Intake Details**
- (2) 12 inch intake lines
 - 80 feet from shore
 - Not in deepest part of Reservoir

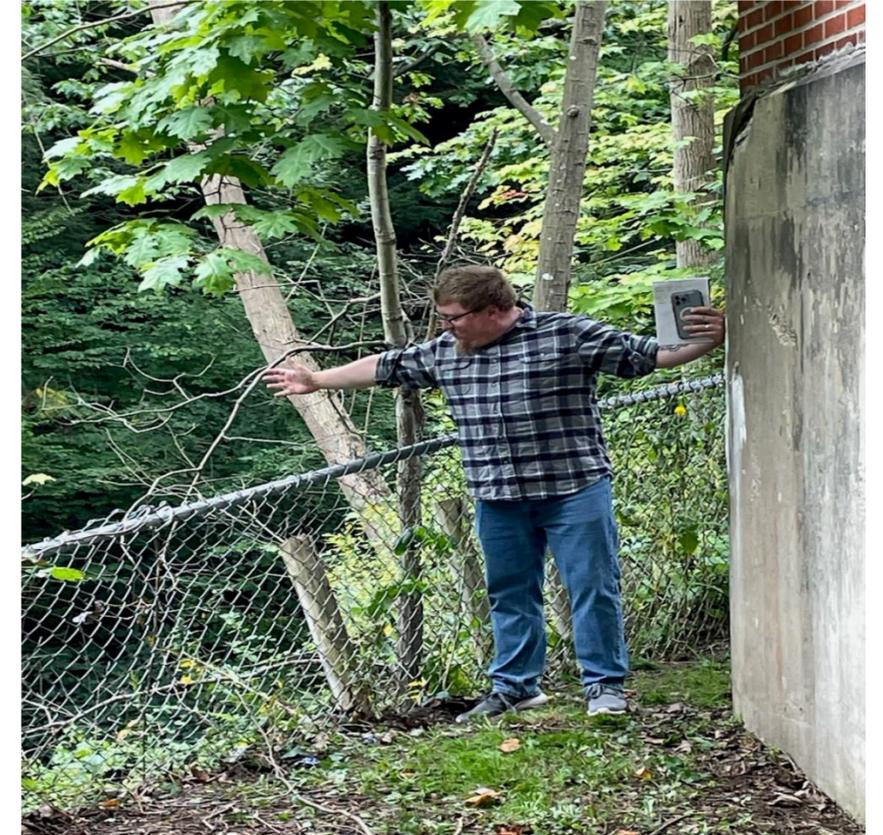
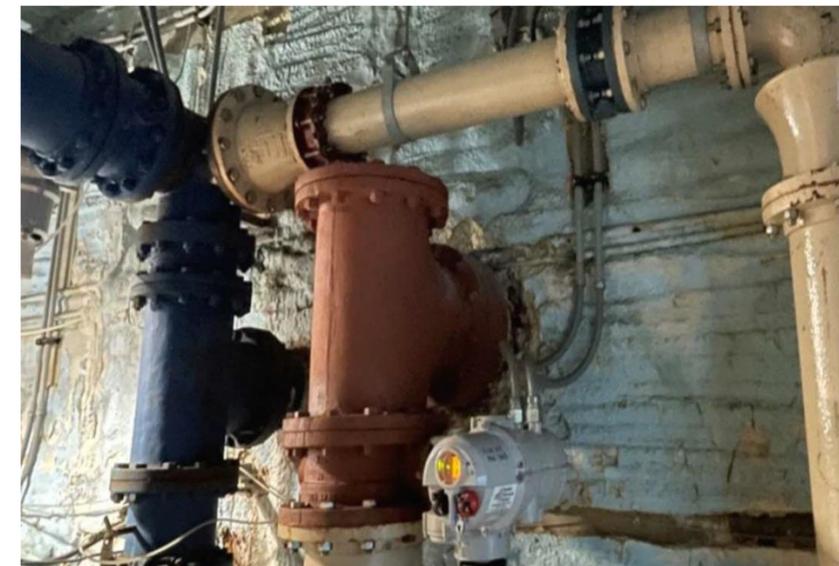
- **Stream bank erosion & undercutting**
 - Clarifiers are on the other side of the wall.
 - Clarifiers hold 250,000 gallons of water, weighing 1,050 tons.
- **Cross Connection between backwash water & finished water lines**
- **Security of facility**
- **Operator safety**
 - Area where chemicals are mixed does not have adequate ventilation and isolation.

Cross Connection between backwash & finished water lines

- Streambank stabilization needed to prevent structural damage to WTP building.
- WTP requires significant equipment upgrades to provide redundancy.
- Continued routine maintenance and upgrades will be required to maintain the plant for future use.
- WTP must continue to operate and be staffed 24 / 7 unless significantly more storage is added to hold finished water and more automation is added to the WTP process.

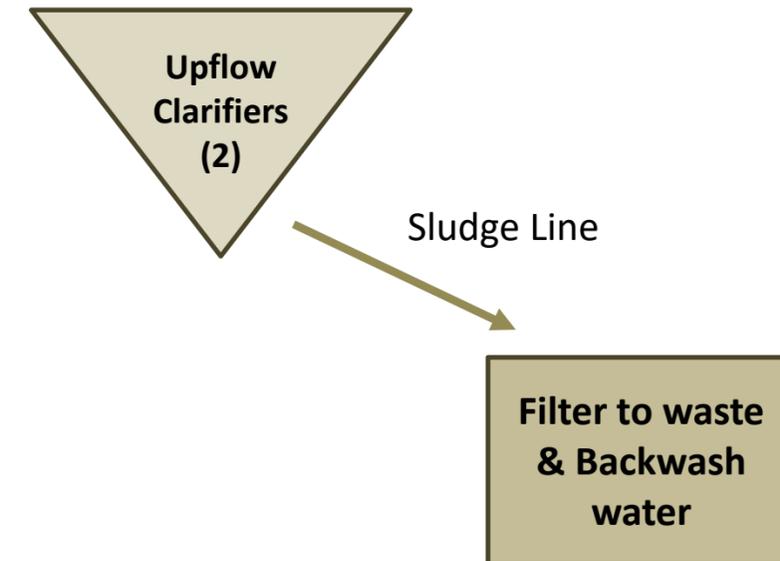
- Clarifier sludge line blocked
- Generator not working
- General condition of the water treatment plant building
 - Cracked walls
 - Color coded labels and directional arrows on water lines are faded / deteriorated
 - Limited size / space for upgrades and back-up equipment / parts

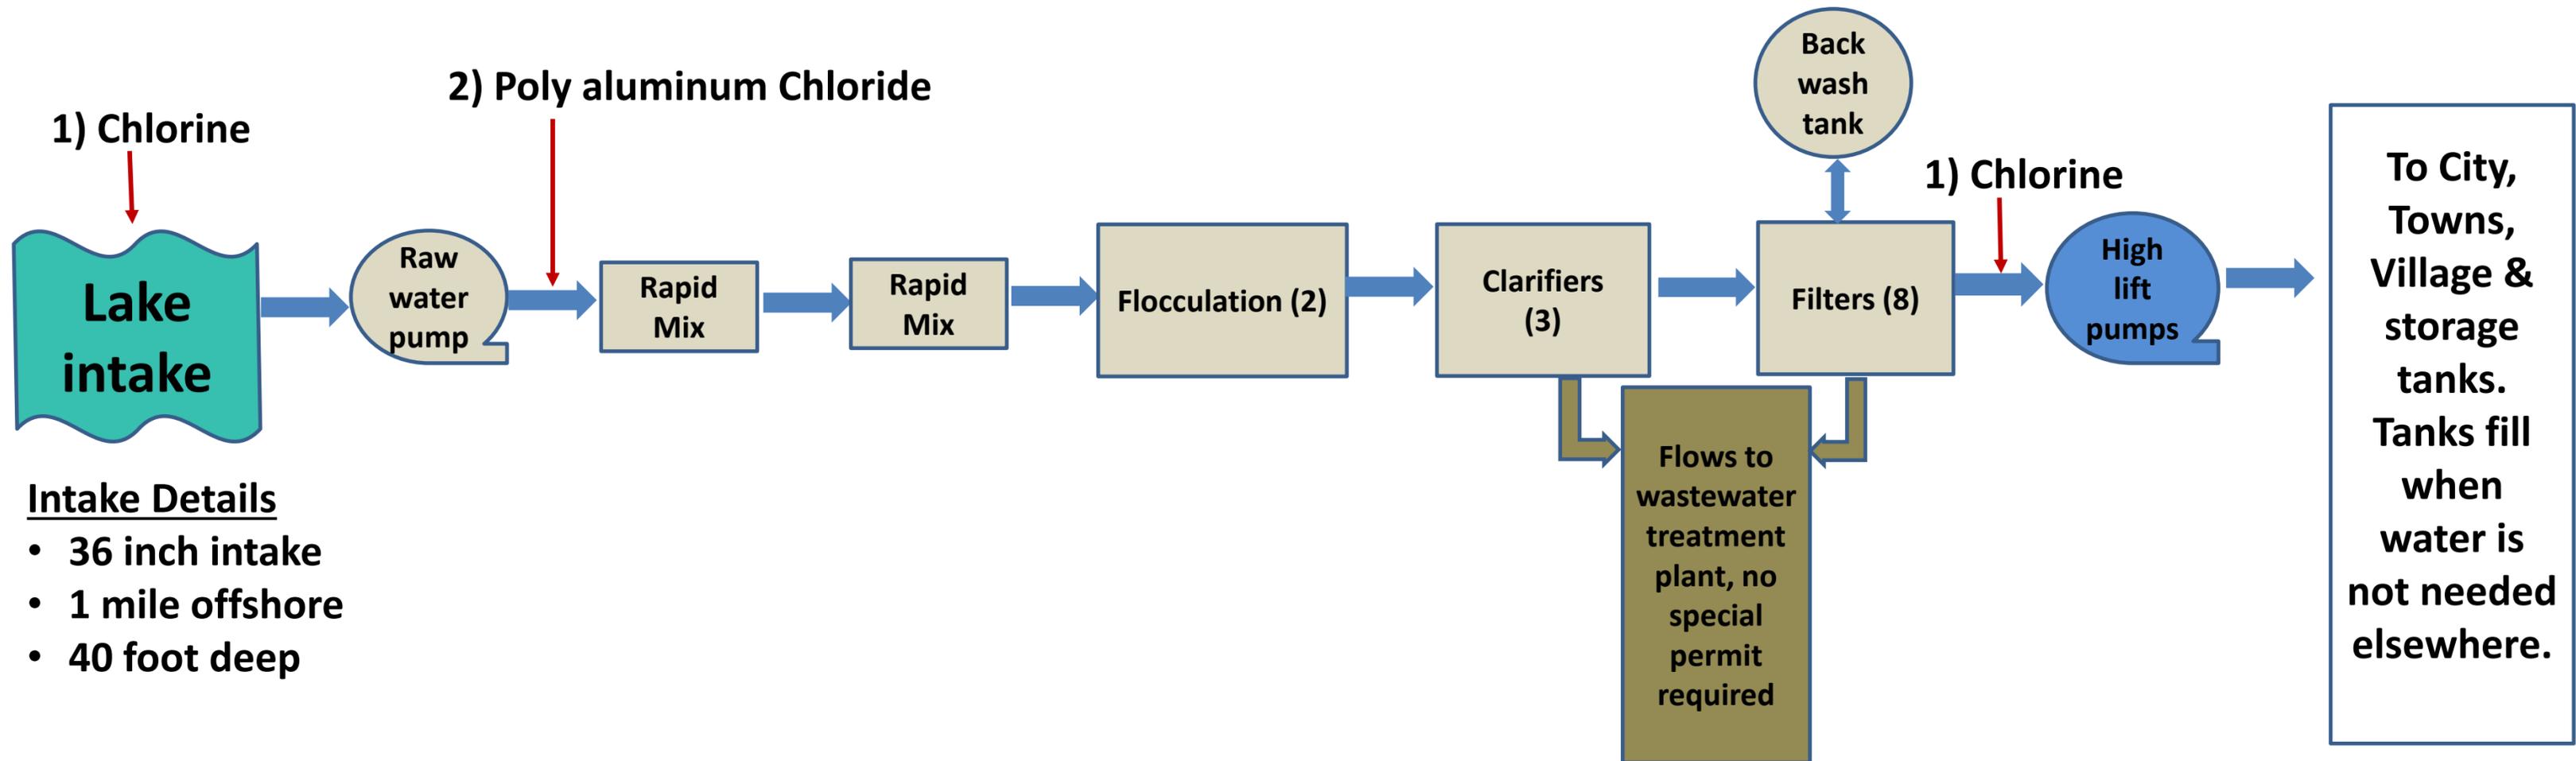
Dunkirk Water Treatment Plant

Dunkirk – 2 chemicals

- Uses pretreatment oxidation to remove organics including disinfection by-product precursors.
- Has sedimentation basins
- Filter media – Granular Activated Carbon (GAC) and gravel absorbs / removes organics including:
 - Disinfection byproducts and precursors.
 - Polyflorinated chemicals – PFOS, PFOA, PFNA.
 - Gasoline and oils.
- Water is not corrosive, so no additional treatment needed to preserve distribution lines.
